P O T T A W A T T A M I E C O U N T Y

D O U G L A S C O U N T Y  
N E B R A S K A

2801000W  
**MISSOURI RIVER BANKS**  
 State Surveyors Office, State of Nebr.  
 Taken From U.S. Army Engineer Plans.  
 Showing Section Lines, Date: 8-1-1962  
 Sheet No. 65 Scale: 1" = 400'

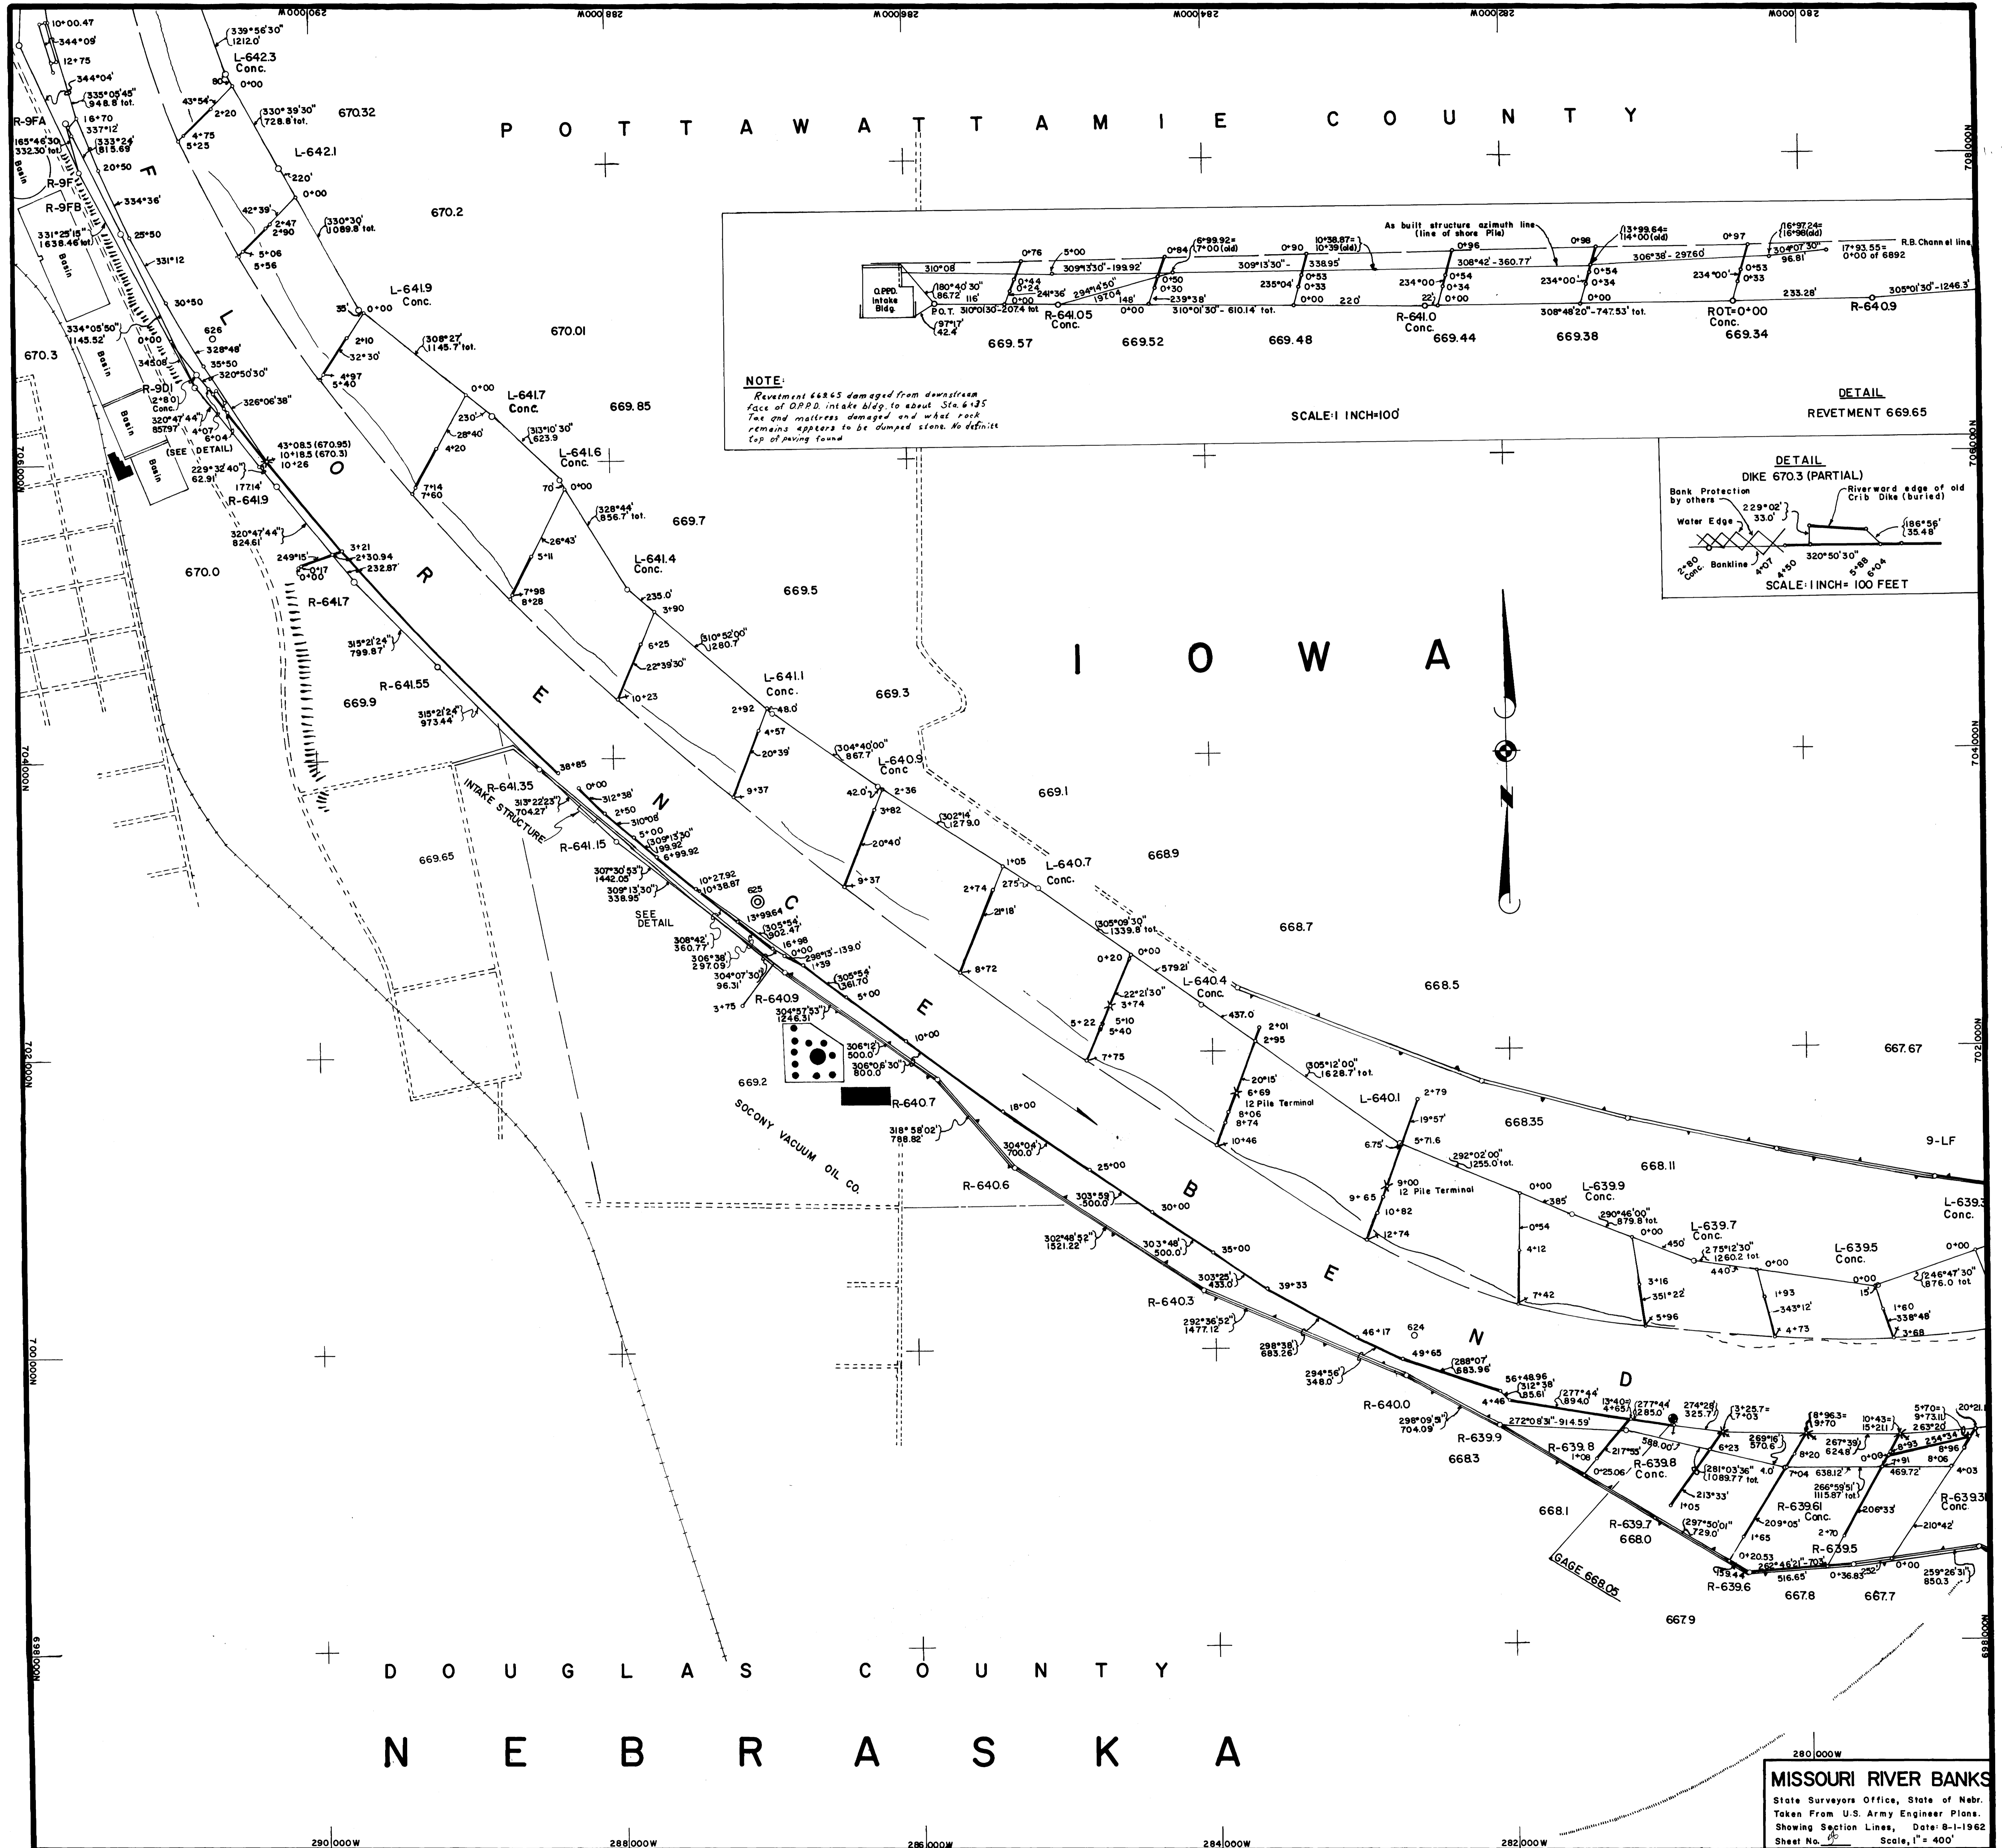
**NOTE:**  
 Revement 668.65 damaged from downstream  
 face of O.P.P.D. intake bldg. to about Sta. 6135  
 Tax and mattress damaged and what rock  
 remains appears to be dumped stone. No definite  
 top of piling found.

**DETAIL**  
 REVEMENT 669.65

**DETAIL**  
 DIKE 670.3 (PARTIAL)  
 Bank Protection by others 229'02"  
 Water Edge 330'  
 Riverward edge of old Crib Dike (buried) 186'56" (35.48)  
 320'50'30"  
 5'88'  
 6'04'  
 2'80' Conc.  
 Bankline 4'07'  
 4'50'  
 SCALE: 1 INCH= 100 FEET
